**Flood Control Project Maintenance
Levee Inspections**

Maintenance Issue Types Only, Levee Inspection Report By Mile - Fall 2014

Sutter Maintenance Yard Tisdale Bypass

Waterway	Bank	Unit Miles	Inspection Start/End	Inspector
Unit No. 01 Tisdale Bypass	Left	4.51	11/10/2014 11/10/2014	Bob Duffey

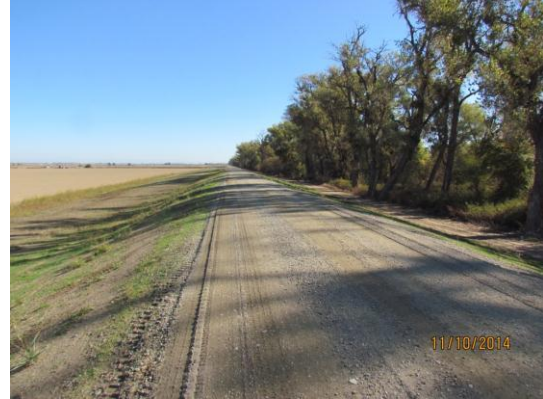
Photo 1 of 1 : FA_2014_ST0009_286_6_20141112_00002.jpg

LM Start	0.71	Rating **	A	Issue No.	6
LM End	0.71	Issue Type +	Ma	Location *	LS
Category	Earthen Levee			GPS Latitude/Longitude	
				Start	End
Item	Vegetation			39.028345 °	39.028345 °
				-121.808753 °	-121.808753 °
DWR ID	DWR_ST0009_01_f_2014_6				
Action/Comments					
Control annual grass and weeds on the levee slopes and easements. Inspector Comments: Sutter Yard has burned and dragged both slopes.

View of the levee with no vegetation on both slopes.

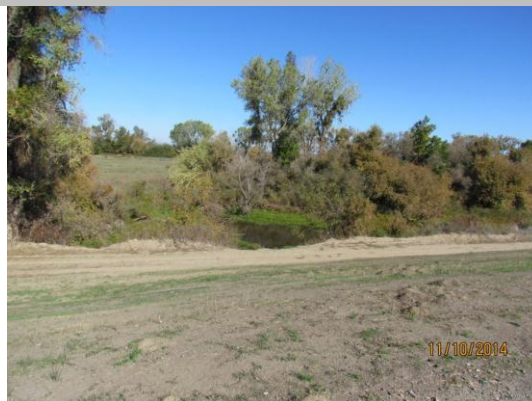
Photo 1 of 1 : FA_2014_ST0009_287_5_20141112_00010.jpg

LM Start	1.50	Rating **	M	Issue No.	5
LM End	1.50	Issue Type +	Ma	Location *	WS
Category	Earthen Levee			GPS Latitude/Longitude	
				Start	End
Item	Erosion / Bank Caving			39.025446 °	39.025446 °
				-121.793347 °	-121.793347 °
DWR ID	DWR_ST0009_02_s_ 2013_5				
Action/Comments					
Schedule repair of erosion site prior to the next inspection.					
Inspector Comments: Sutter Yard needs to monitor the erosion.

View of the erosion along the waterside berm.
